# THE RANCH

## COMMUNITY WILDFIRE RISK ASSESSMENT

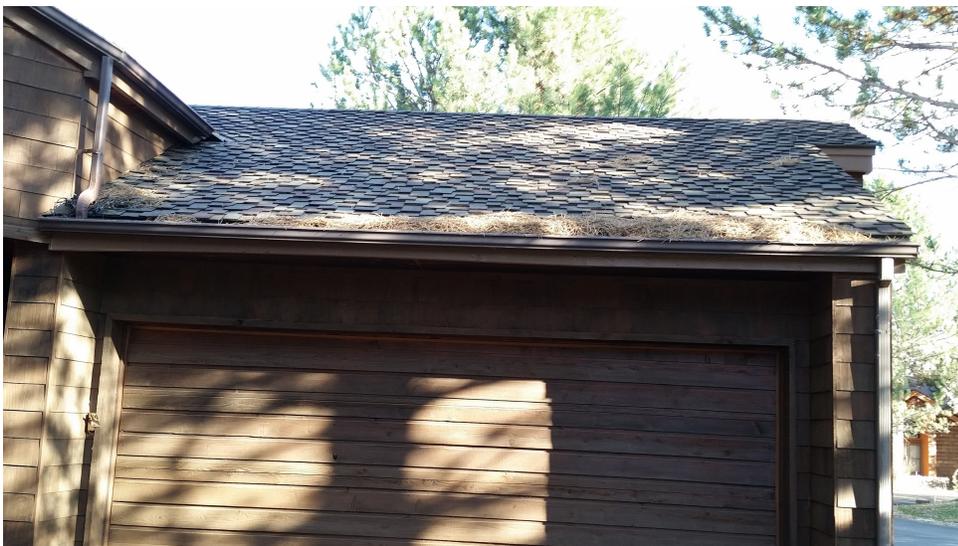
Due to extensive, well-mowed grass in the neighborhood the likelihood of surface fire spread is slim. The most likely source of fire spread would be from a house fire where flying embers drop onto nearby combustible materials on an adjoining home. The same scenario could play out if there was a crown fire burning on the San Juan National Forest, especially to the west of the community, and sparks and embers landed on shake shingle roofing and combustible materials near homes; burning embers from the Missionary Ridge and Valley fires in 2002 rained down on The Ranch. The large, broad tree crowns could provide a good vector for fire spread among often-closely spaced structures. While embers are most likely to ignite a home, trees could easily carry fire from structure to structure.

**Comment 1: Trees overhanging homes also drop needles which can accumulate on rooftops and in gutters. The roof edge is a particularly vulnerable part of most homes.**

At the recommendation of the current Ambassador, a retired forester, the HOA removed hazard trees (especially dead and dying aspen) and pruned pines and spruce four times during 2015-2016 in the common spaces between the houses. At the same time, some homeowners removed trees and tree branches overhanging their roof or touching the sides of the houses, using CSFS guidelines as much as possible, especially in zones 1 and 2. In both years, the HOA took advantage of FireWise's Chipper Rebate Program.

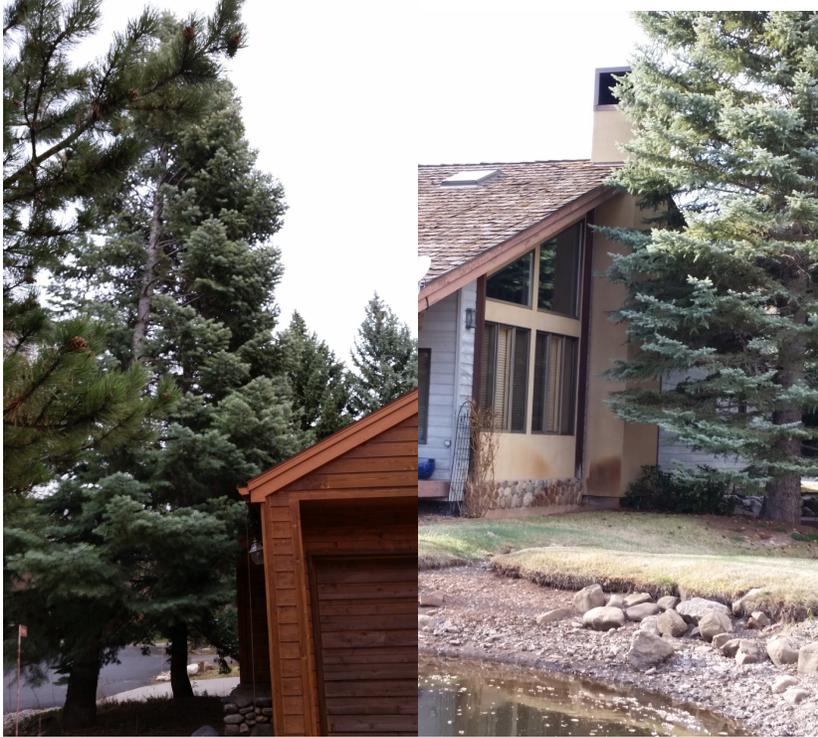
**Comment 2 Left:** Though trees are well irrigated and construction details include a stone barrier adjacent to the wood siding, gutters trap needles from nearby and overhanging trees, leaving this garage particularly vulnerable at its eaves. **Right:** This home has decent defensible space but is extremely vulnerable due to its shake shingle roof.

- HOA replace wood shake roofs on mail house and pump house/storage shed
- Strongly encourage homeowners who still have wood shake roofs to replace them as soon as is financially possible
- Use the Community Assessment as an educational and inspirational tool for homeowners to comply with CSFS guidelines for defensible space and home hardening

- Identify and continue to remove any flammable material (trees, shrubs, etc.) within zones 1 and 2 of homes; this will involve a mixture of work in common areas by the RPOA and private space by homeowners
- Ensure that addresses are clearly marked and visible (reflective) for each home
- Replace wood street signs with reflective metal signs
- Organize a concerted effort to educate and encourage homeowners about readiness and evacuation planning as well as development of a community wide plan
- Encourage residents to register for Code Red (La Plata County Emergency Notification System)
- Seek Firewise Communities USA recognition
- Identify and clearly mark an alternative exit to The Ranch that could be used if the main entrance/exit is blocked
